Subject: EPA Contract No. 68-W8-0084  
Work Assignment No. 31-5JZZ  
Revised Trip Report for Site Visit  
to Sauget Areas No. 1 and No. 2  
Sauget, Illinois, May 3 and 4, 1993

**SITE VISIT PHOTOGRAPHIC LOG  
(11 Pages)**

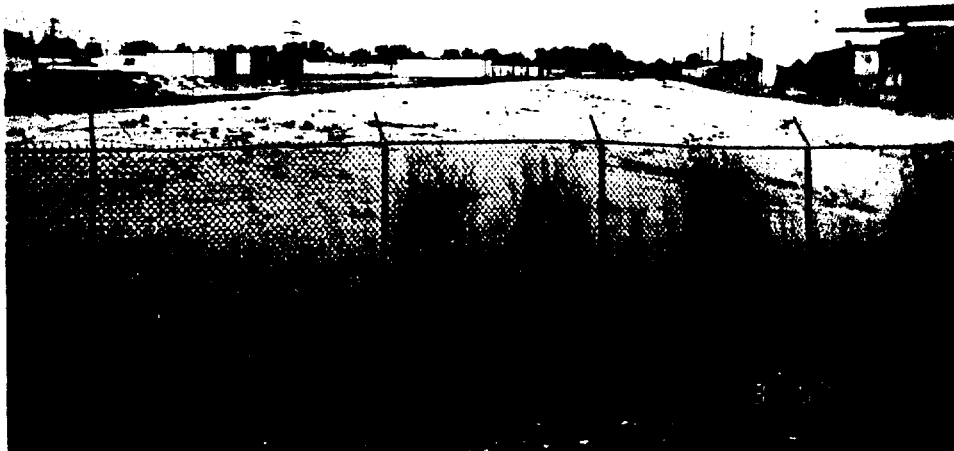
Photograph No. 1 Location: Creek Segment A  
 Orientation: South Date: 11/1/83  
 Description: Northern end of CS-A: CS-A has been filled in by Cerro Copper; parts of Cerro Copper and Site I are visible at the right and left sides of the picture, respectively.

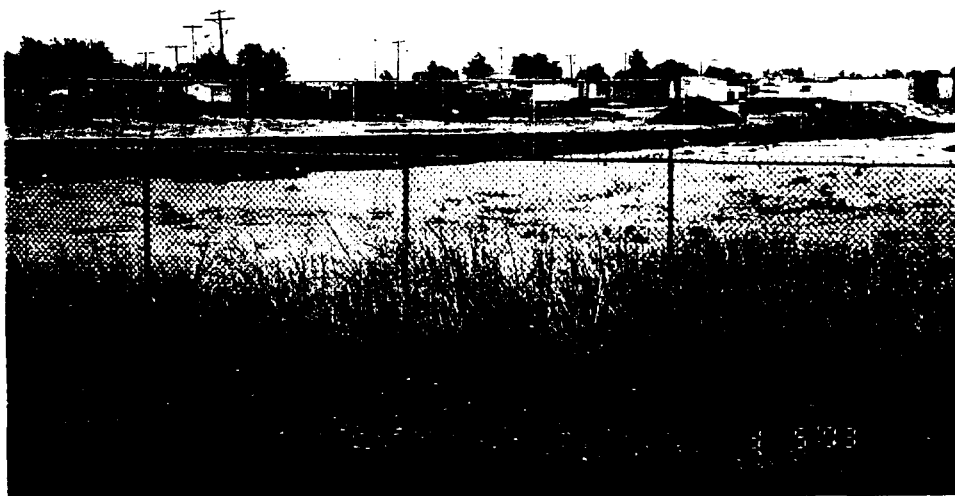
Photograph No. 2 Location: Creek Segment A  
 Orientation: Southeast Date: 11/1/83  
 Description: Northern end of Site I located immediately east of CS-A.

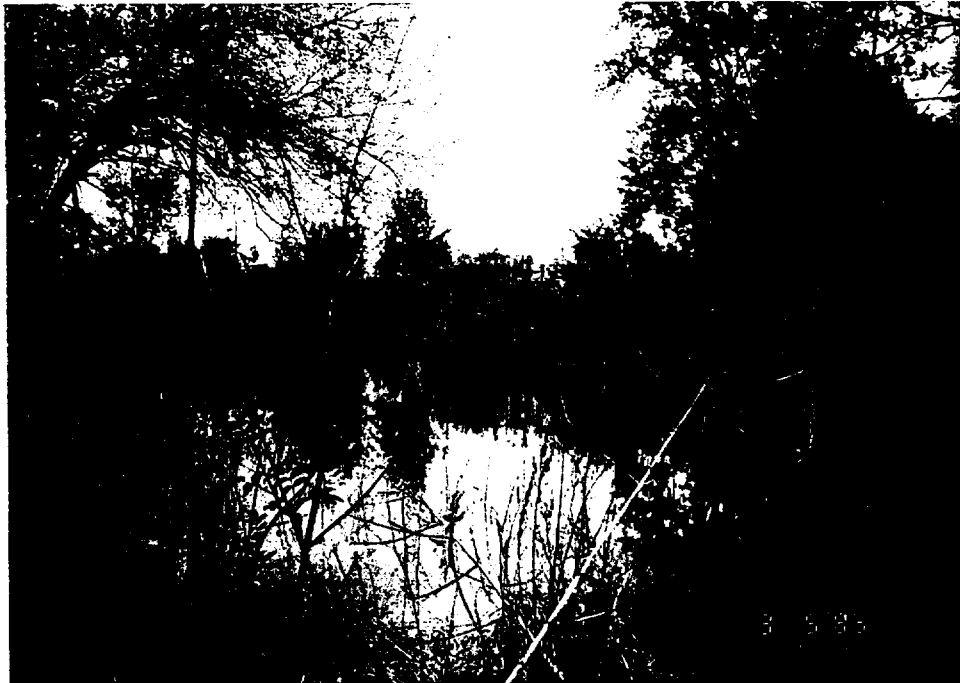
Photograph No. 7

The site visit continued at the southern end of CS-B along Judith Street. PRC observed no water flow through the culvert between CS-B and CS-C; both CS-B (see Photograph No. 7) and CS-C appeared to be stagnant. A green heron was observed sitting on a dead branch in CS-B.

Description: Southern end of CS-B viewed from Judith Street: access is restricted by a fence constructed around CS-B by IEPA.

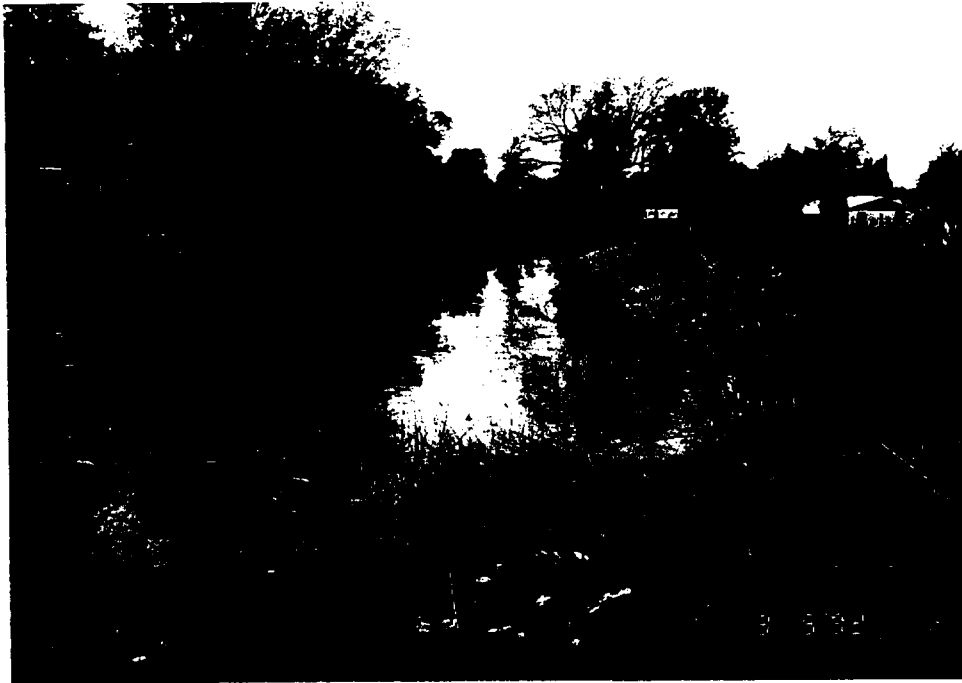
Photograph No. 9

Description: Northern end of CS-C: access is unrestricted.

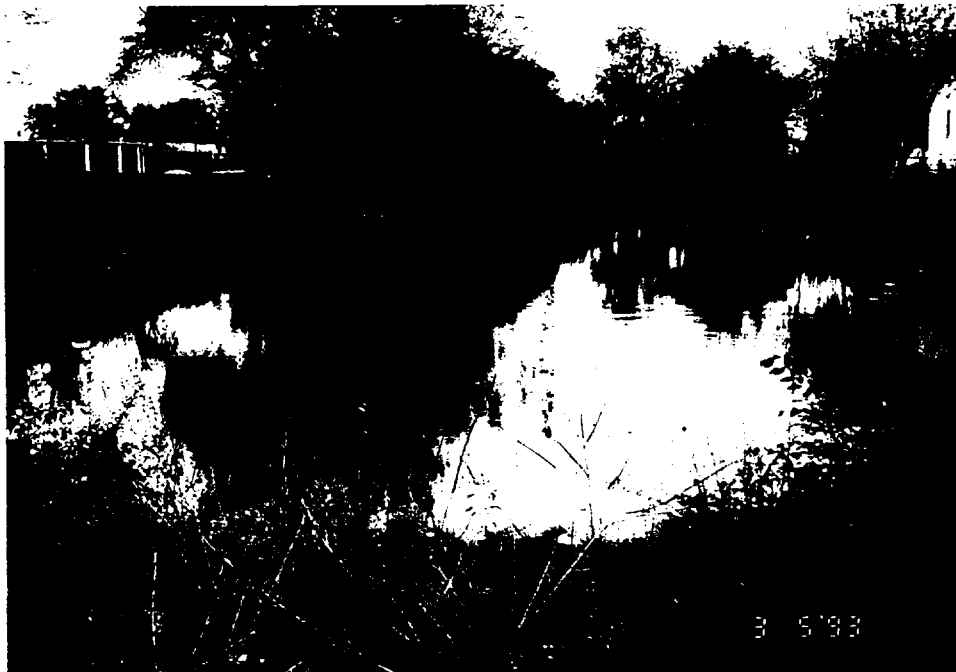
Photograph No. 10

Description: Southern end of CS-C

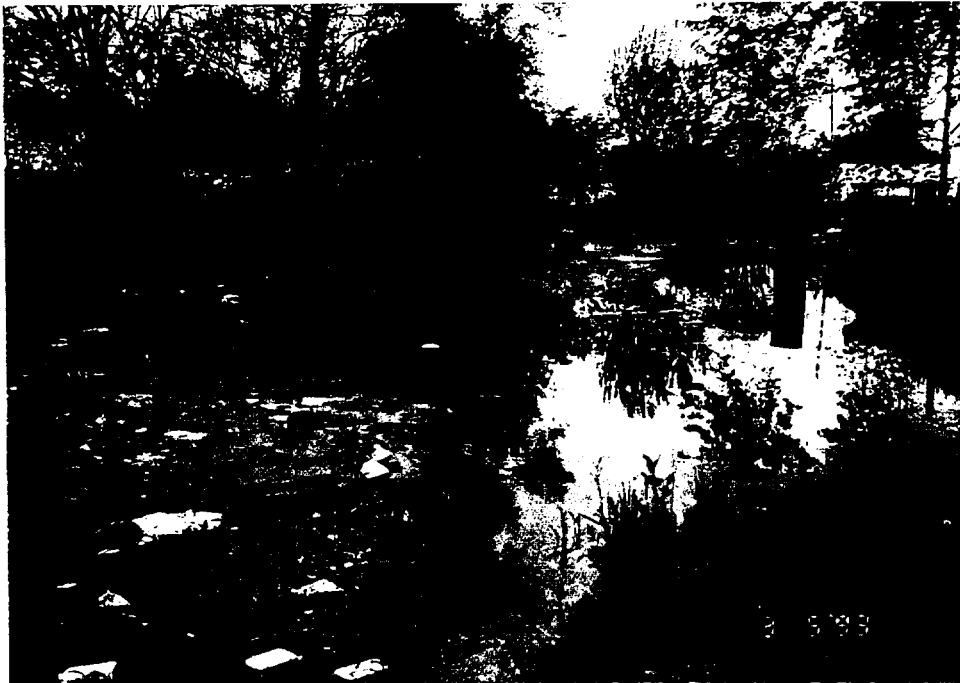
Photograph No. 11

PRC observed no water flow through the culvert between CS-C and CS-D at Cahokia Street; both segments appeared to be stagnant (see Photographs No. 9, 10, and 11). In addition, PRC did not observe any water flow through the culvert located at Kinder Street between the northern and southern portions of CS-D (see Photographs No. 12 and 13). However, PRC did observe water flow through the culvert located at Jerome Street between the southern portion of CS-D and CS-E (see Photograph No. 14). Therefore, it appears that the southern portion of CS-D and CS-E may be combined for evaluation of the surface water pathway (see Photographs No. 15 through 19).

Description: Northern end of the northern half of CS-D viewed from Cahokia Street: culvert appears to be blocked, as is evidenced by the stagnant water.

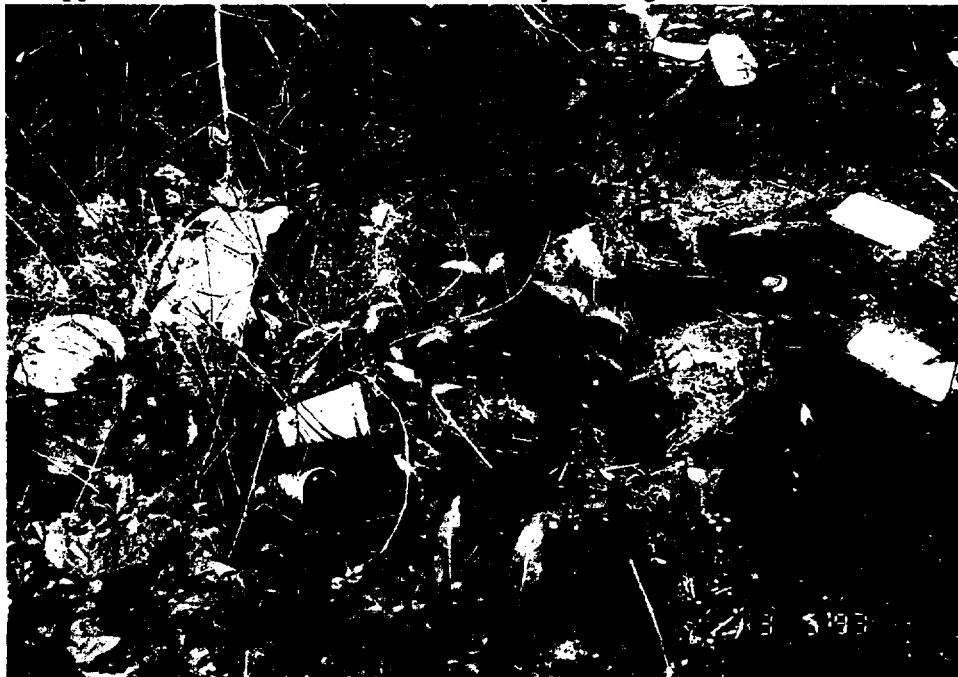
Photograph No. 12

Description: Northern end of the culvert between the two halves of CS-D: the culvert appears to be blocked, as is evidenced by the stagnant water.

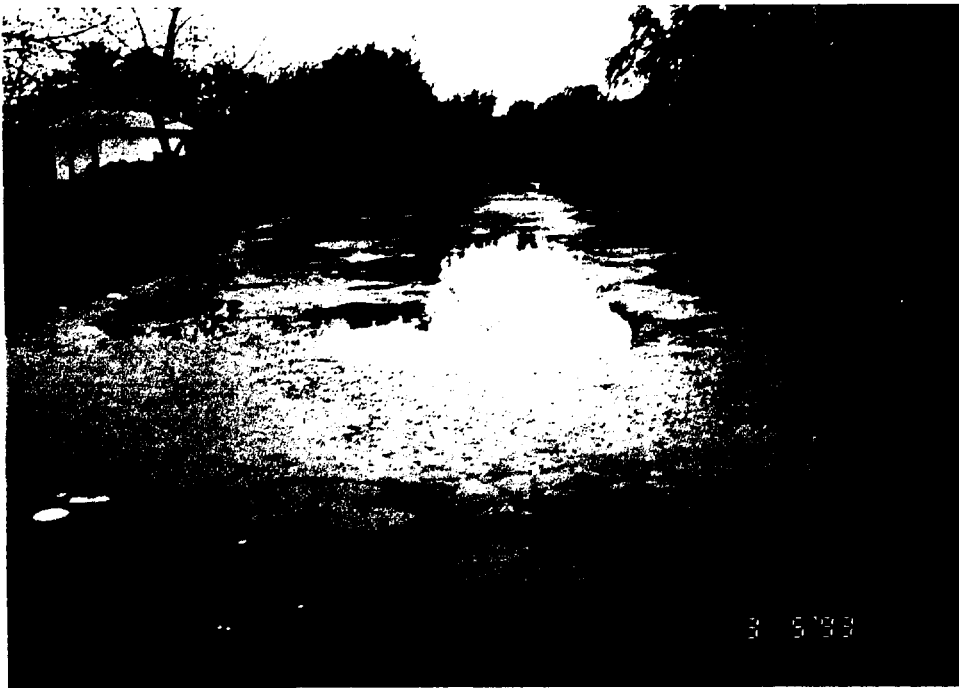
Photograph No. 13

Description: Northern end of the southern half of CS-D viewed from Kinder Street.

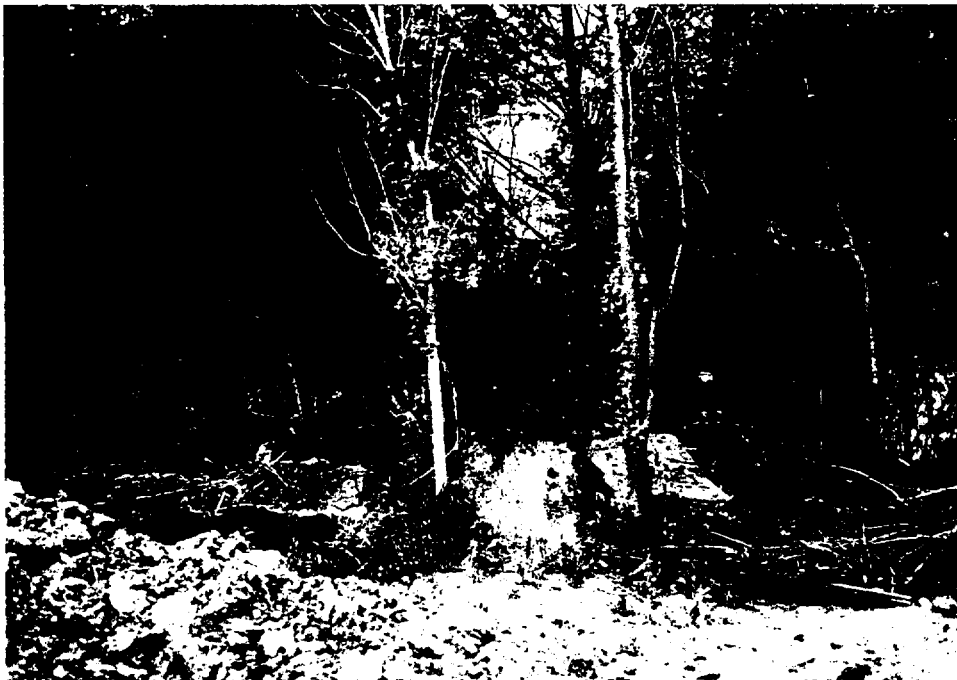
Photograph No. 14

Description: Northern end of CS-E viewed from Jerome Street: the culvert between CS-D and CS-E at this location is partially open. Water flow was observed.

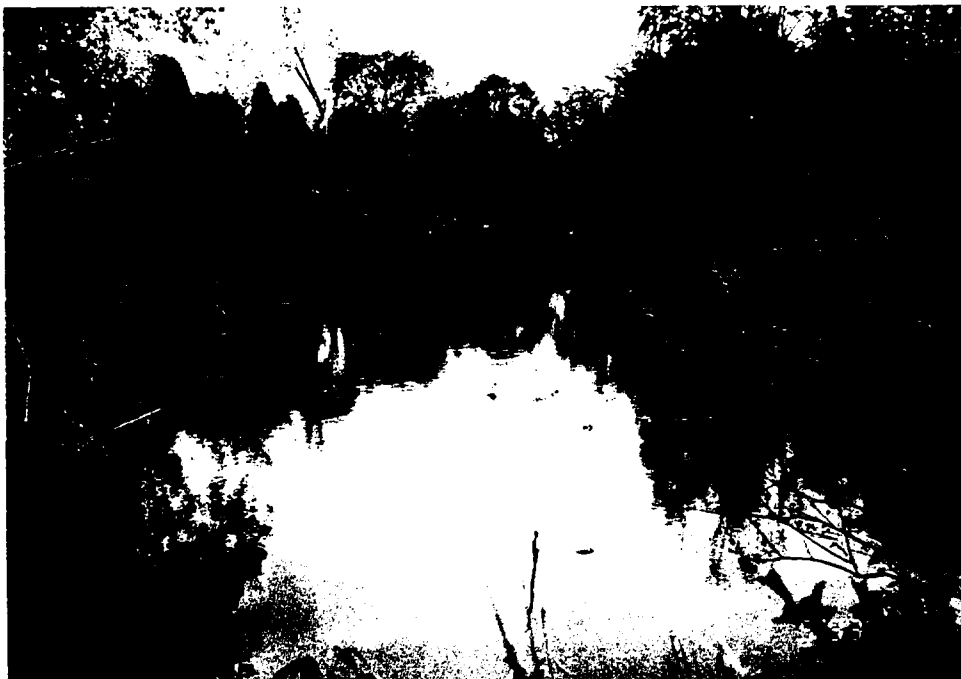
Photograph No. 18

Description: CS-E viewed from Edgar Street: Edgar Street dead-ends west of CS-E in the parking lot for the Jaycee building.

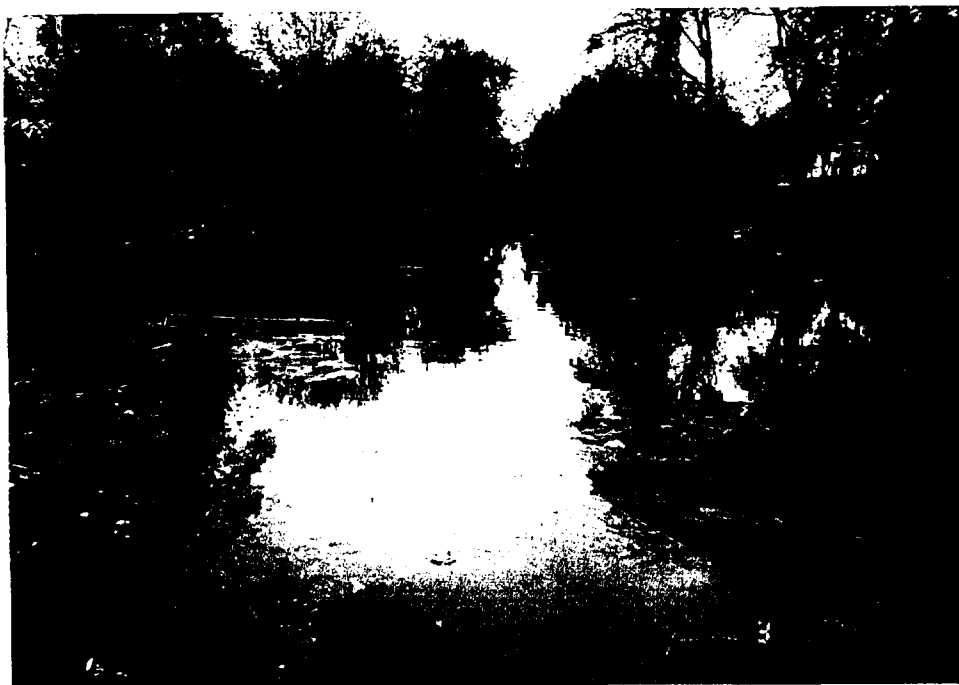
Photograph No. 19

Description: CS-E viewed from Edgar Street.

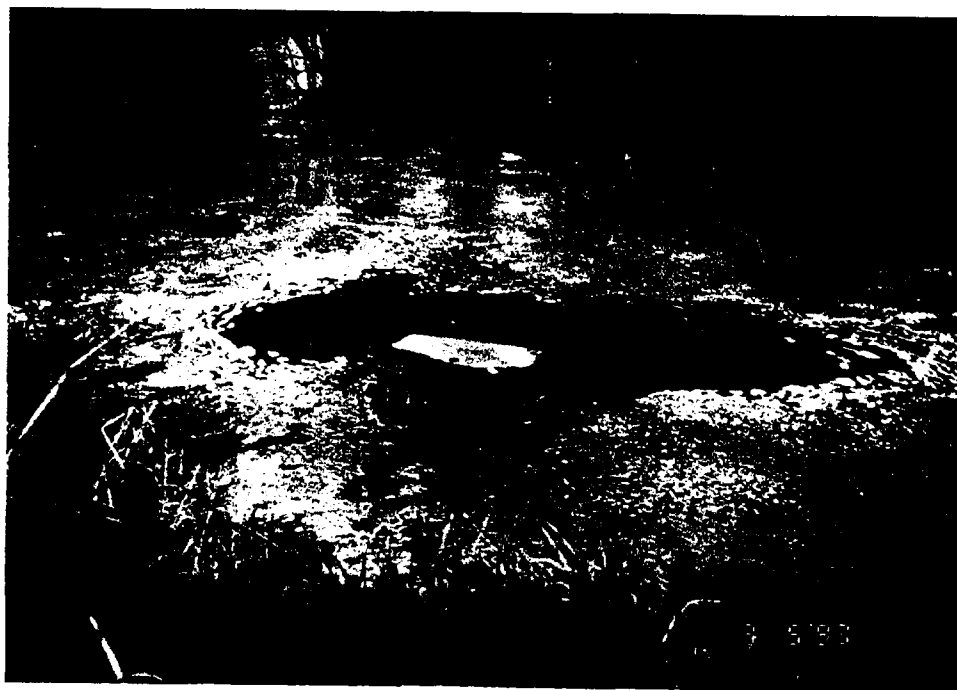
Photograph No. 20

PRC and IEPA representatives drove to the point where Dead Creek meets the Old Prairie DuPont Creek. The wetlands at the southern end of CS-F were covered with an orange-red algae covering an area about 30 yards by 100 yards. Stressed vegetation was observed, as were overflow structures at regular intervals along the eastern side of the wetlands (see Photographs No. 20 and 21). PRC and IEPA representatives returned to their respective hotels at about 6:30 p.m.

Description: Overflow structure along the western bank of the wetlands: note the orange-red algae at the southern end of the wetlands.
